**Ragley Home Farms is a 3,500 acre arable Farm, surrounding the historic Ragley Hall. A LEAF Demonstration Farm, the company practises Integrated Farm Management. IFM is a whole farm, sustainable approach producing healthy crops and livestock in an environmentally responsible way. And as part of that plan Farm Services Ltd has worked in partnership with Farm Manager Hamish Stewart to improve the estate's drainage.**

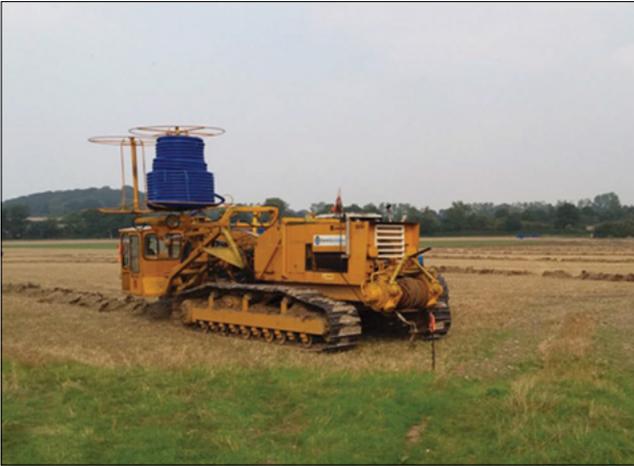
The design in this field utilised some of the existing main drains where they were proven to be in good working order

and we raised the depth of the new drains to prevent damaging the existing ones, whilst old drains were not working well there is little point in damaging something which is moving some water.
